**Botswana
Geoscience
Institute**
Excellence in Geoscience

Sinkholes, Land Subsidence And Earth Fissures In Botswana

April 2021

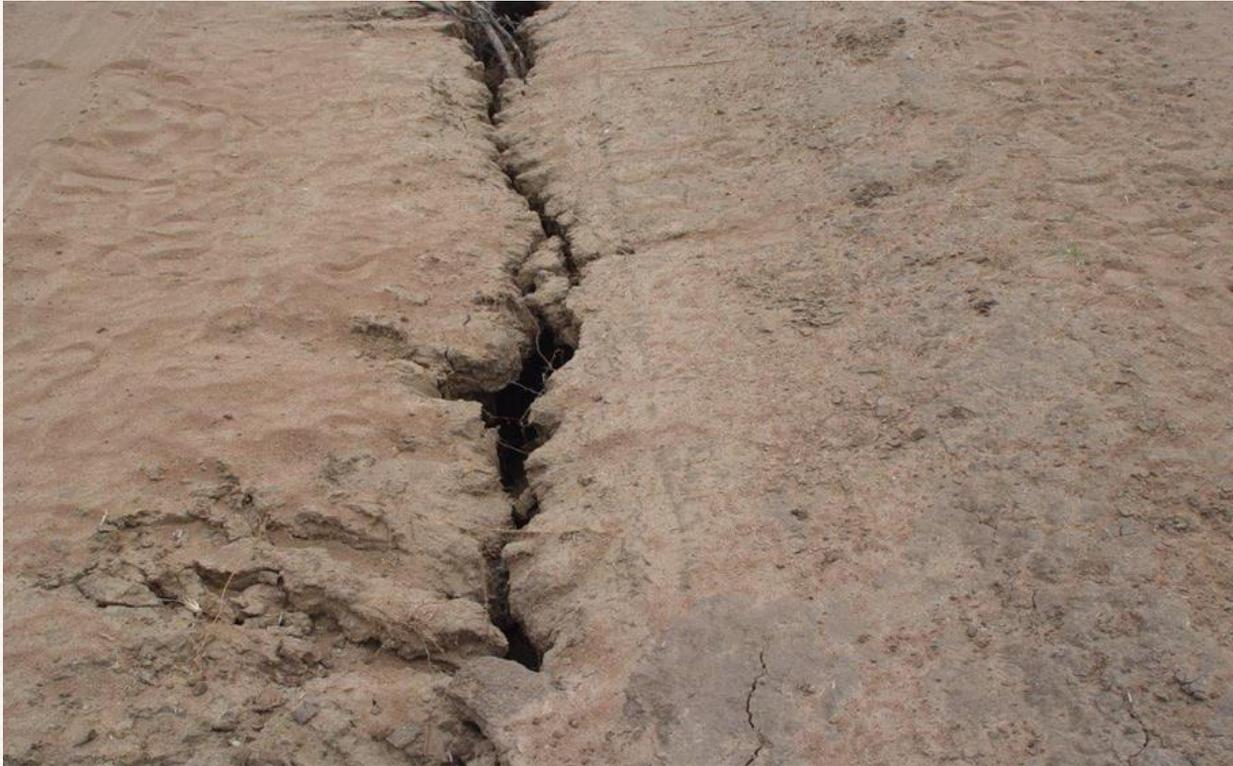
Figure 9: Earth fissure in Makapane

A linear earth fissure affected a dirt road leading to cattleposts around Makapane lands, 12km south west of Moshaneng village in Ngwaketse west, Southern District (figure 9). The observed fissures affected about 0.18hactres of the area, however GPR results, a geophysical method showed that there were other concealed fissures over an extensive 0.48hactres coverage. Although the fissures are not extensive they may pose threat to road users and livestock in the area.

It is significant to note that these fissures occur in Waterberg sediments underlain by cherts and dolomitic rocks. In the long run these fissures may act as conduits for water ingress which may trigger an extensive collapse within dolomitic rocks. However, the causes of these earth fissures is unknown and yet to be established.

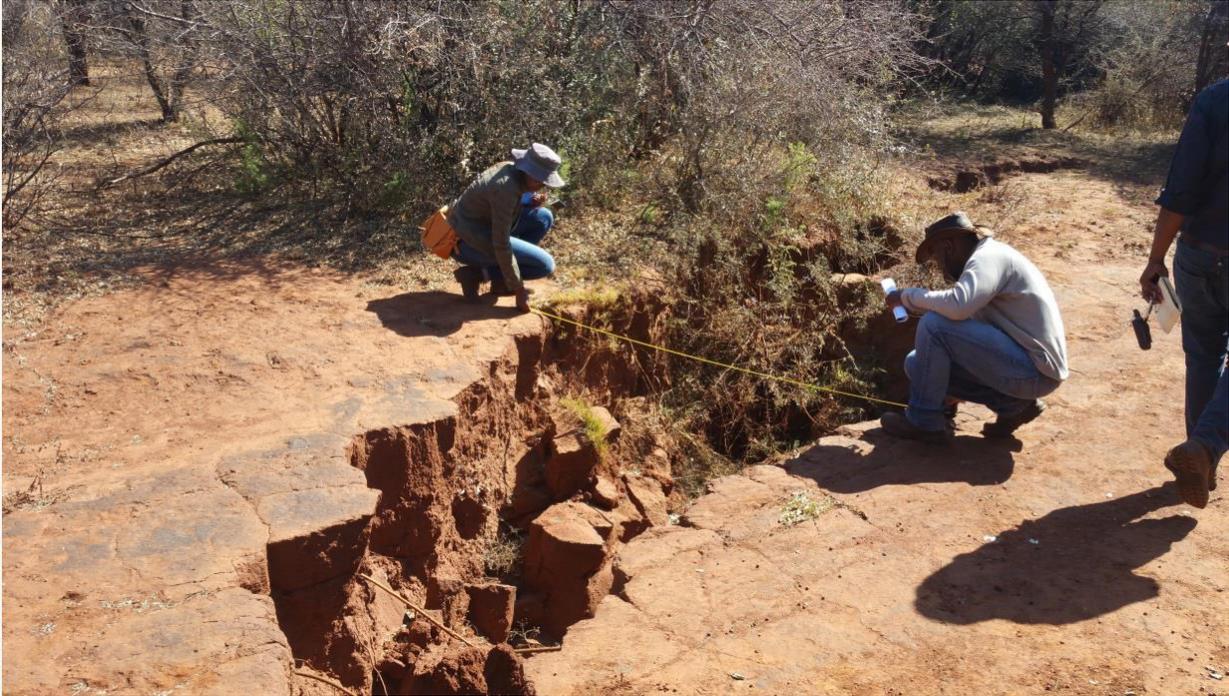
Figure 10: Ground fissures around kgwakgwe wellfield .

Extensive linear earth fissures occurred in Kgwakgwe wellfield, in Ngwaketse area, south of Kanye major village. These fissures were 300 ,2.2 and 1.8metres long,wide and deep respectively (Godirilwe et al., 2017) affecting around 0.4ha area within the wellfiled (figure 10) . Kgwakgwe wellfiled have been established to supply water for major villages such as Kanye and Moshupa villages.

According to DWA, 2006, the wellfiled is established in a karstified dolomitic aquifer. Godirilwe et al., 2017, concluded that the these fissures were a result of high abstraction rate of groundwater that exceeded natural recharge occurred in a karstified acquirer thus causing an instability that manifested as ground fissures.

This groundwater lowering due to over abstraction could result into sinkholes formation.The receptacles could be created when removing the water that initially filled the karst cavities hence causing the blanketing layer to collapse in pursuit of filling the gaps , leaving holes at surface (a typical dewatering sinkhole scenario).

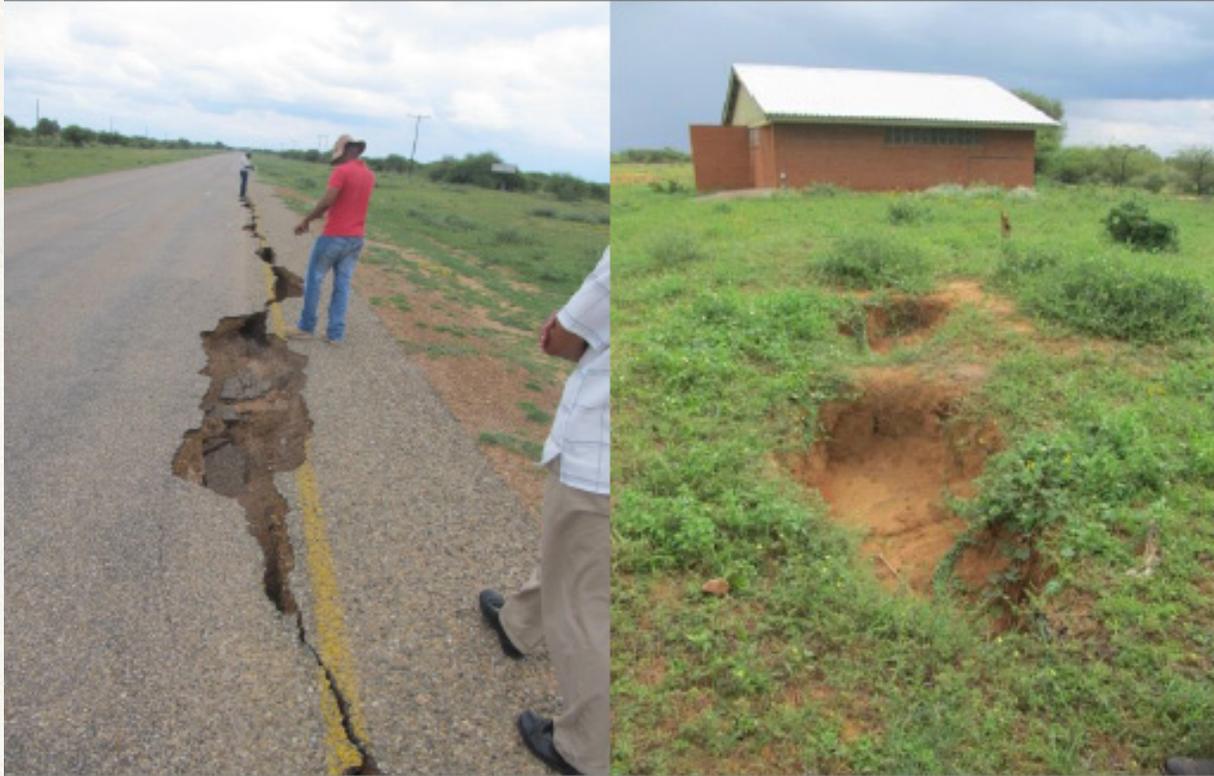
The ground fissures in Hatsalatladi occurred along and besides the tarred Lephephe-Molepolole road causing a significant damage as shown in Figure 11a. This at some point caused solemn disruption of transport system as the road had to be temporarily closed for road users safety. Another set of fissures occurred in a local primary school just few meters east of the main tarred road (Figure 11b). In both cases the discontinuities that were observed, posed a geohazard risk to the roadusers, public, school staff and students.

However, the cause of these earth fissures is unknown and yet to be established.

Figure 11: a) A Damaged road in Hatsalatladi due to fissuring; b) Earth fissures within Hatsalatladi primary school premises.

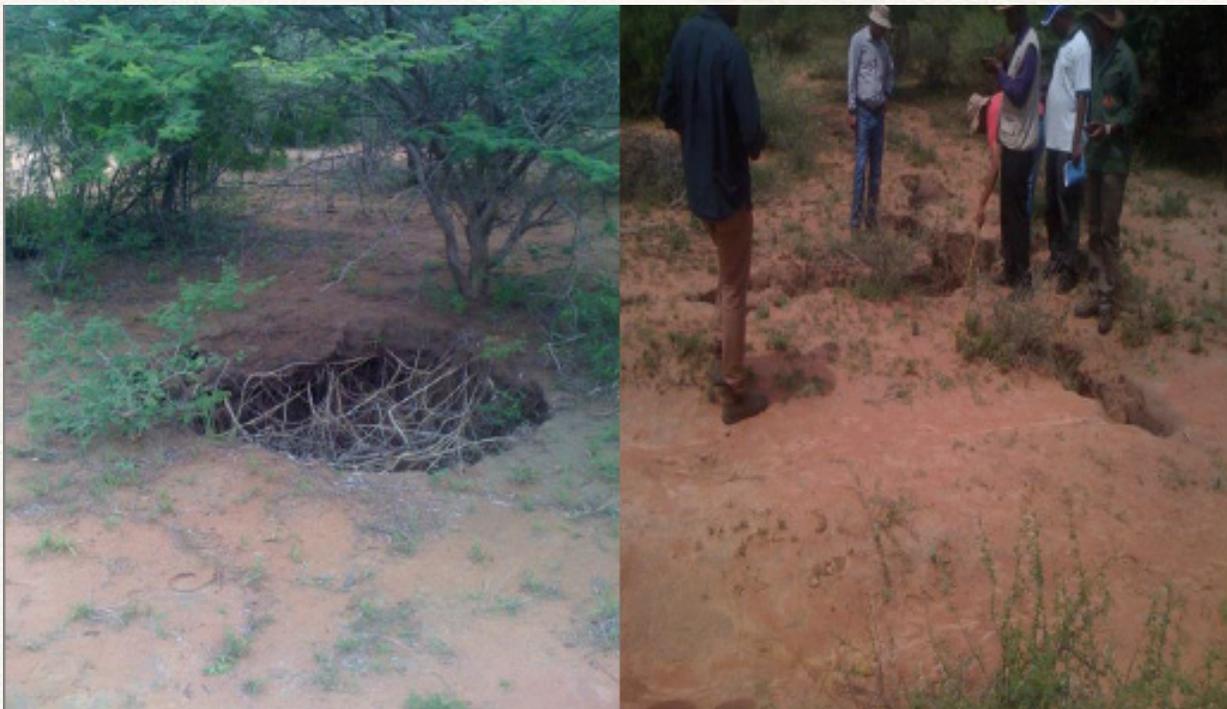
Ground deformation in Ditshukudu occurred in the form of three different cluster trends that seemed to fall into circular arcs (Tobani et al., 2016). The fissures were upto 1metre wide with sub vertical scarps on either sides. The other set of fissure were linear persistent for 5-10m. Based on the trends of cracks, it is indicative of possible emergent subsidence manifesting itself as visible earth fissures and depression (Figure 12).

The cause of this subsidence and earth fissure is currently unknown in Ditshukudu, however hydrocompaction and shrinkage of expansive soils have been hypothesised.

Figure 12: a) a depression observed in affected area; b) tripple junction of different trends of earth fissures in Ditshukudu, Kweneng District.

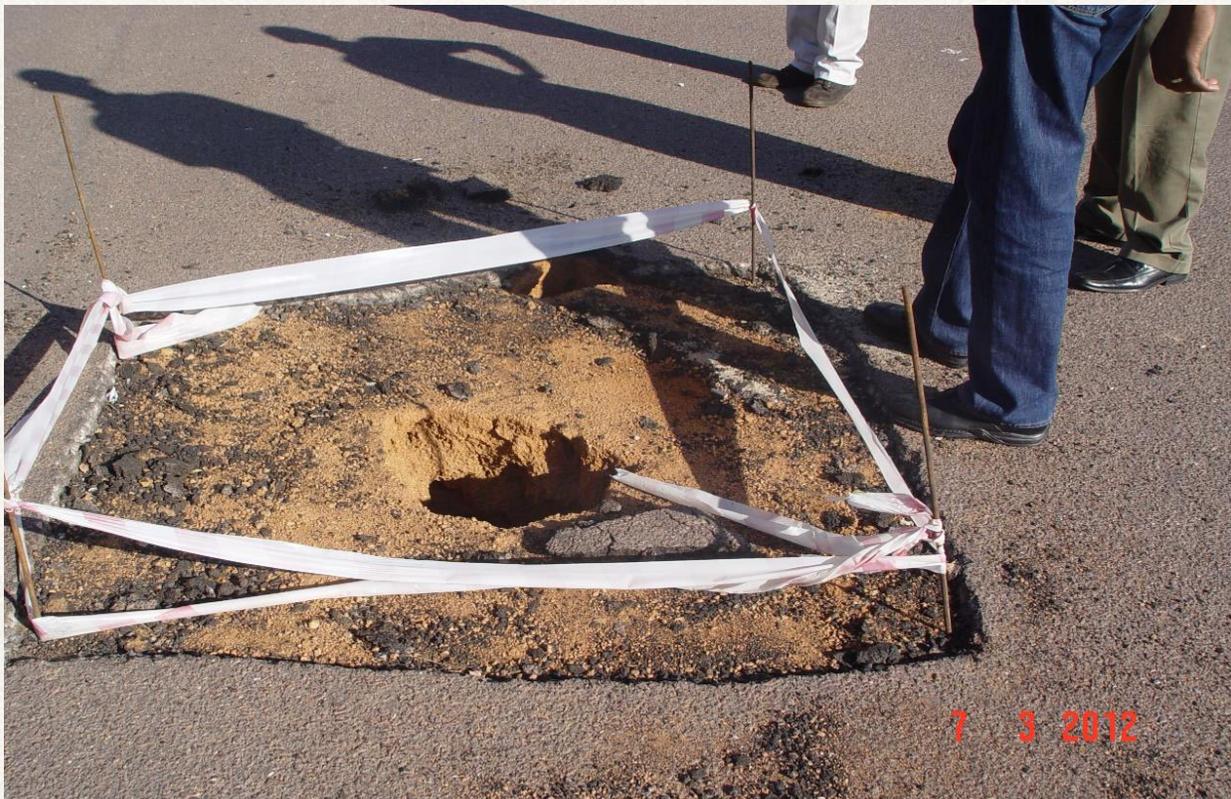
A non-catastrophic small sinkhole occurred in a parking lot of the Civic Centre in Lobatse (Figure13). The affected area is underlain by dolomites as verified by Total magnetic intensity (TMI) results (Ramaselaga, 2012) in the same study GPR results confirmed presence of subsurface void at a shallow depth.

Figure 13: A sinkhole that occurred in Lobatse, South East District.
