**Botswana
Geoscience
Institute**
Excellence in Geoscience

Sinkholes, Land Subsidence And Earth Fissures In Botswana

April 2021

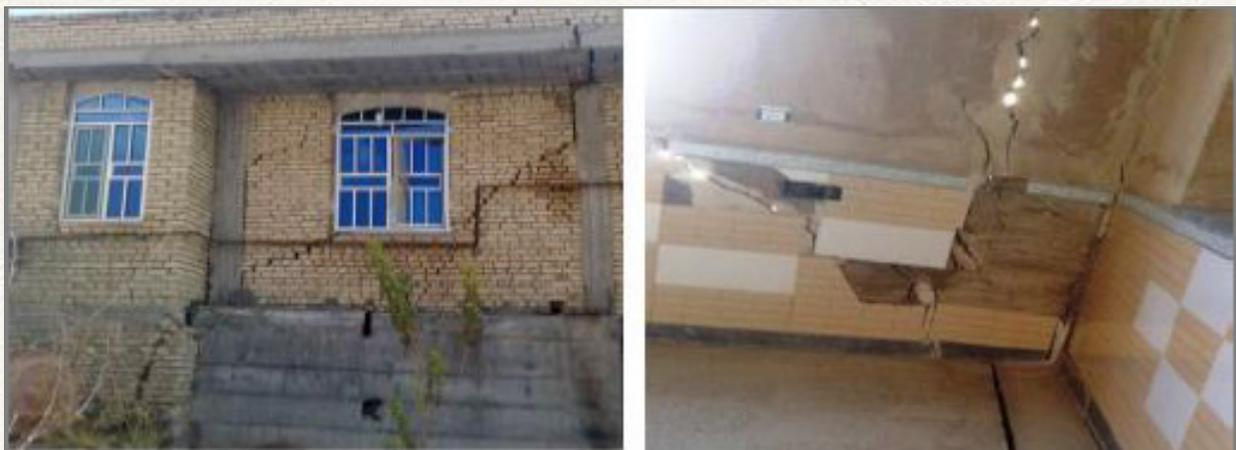
- Cracked or collapsing roads
- Cracked building foundation and walls (Figure 7).
- Loss of human settlement, infrastructure and agricultural land
- Loss of life and injuries to animals and human.
- Broken pipes & utility lines
- Damaged borehole casing
- Contaminated groundwater aquifer
- Changes in elevation and slope of the ground surface, possibly affecting drainage

Figure 7: Diagonal, Tapering cracks, typical sign of subsidence on buildings (Hossein Rahnema, Sohrab Mirasi, 2012).

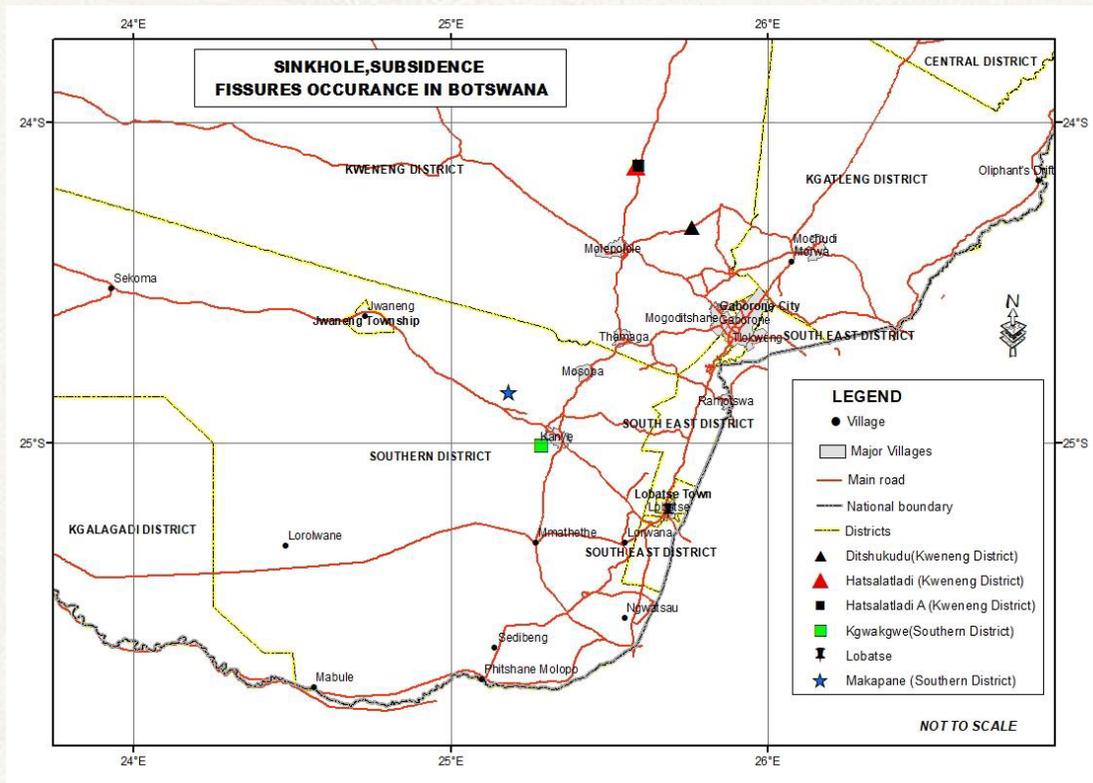
The most common earth collapse or instability in Botswana is earth fissuring. There are several occurrences reported around the country as shown in figure 8 below, where they have caused a variety of infrastructural damages and land management problems. A non-catastrophic sinkhole(s) have been reported so far. covers approximate- ly 26 square metres.

Figure 8: Occurrence of sinkholes, subsidence and earth fissure in Botswana
